**King County**

Metro Transit Division

## **PRELIMINARY REPORT**

Electrical Shock Injury

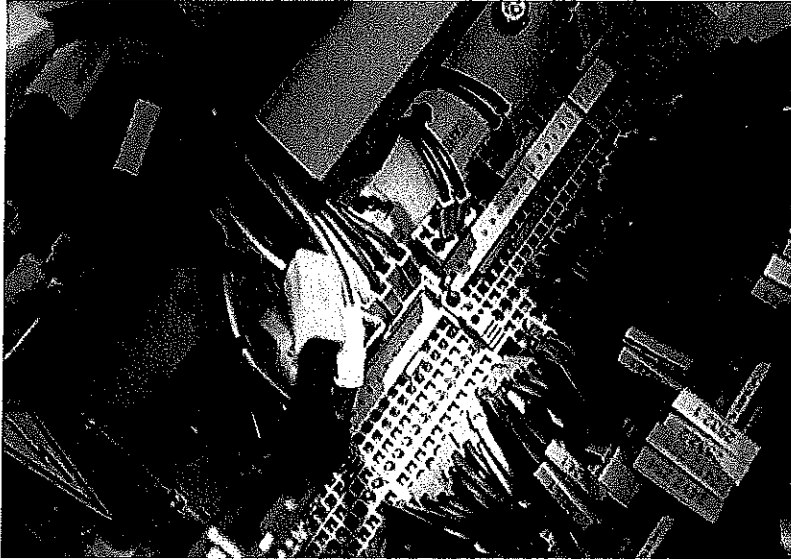
X61 sticker – the X60 was not seen during this investigation.

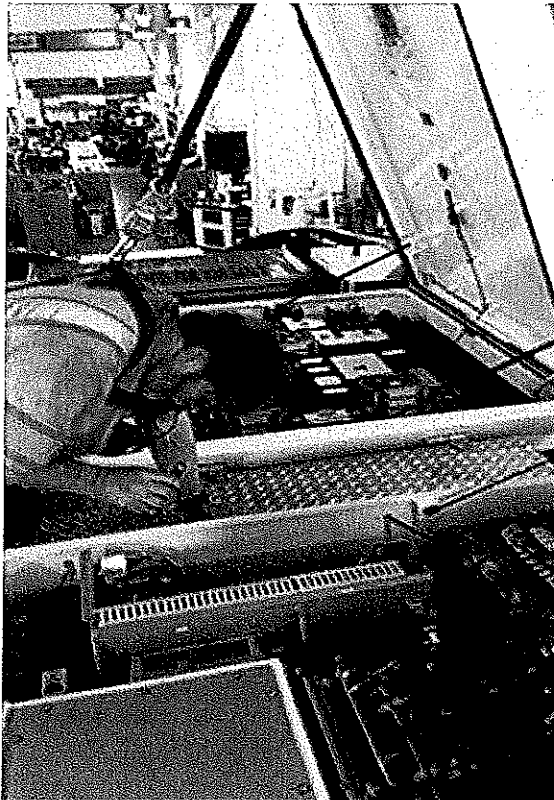
Found loose connector X60 on rooftop insulation check board CPMA1 (in RAC). X60 is the connection from the CPM 202 to the chassis through the A1 board. Without proper reference

to chassis the CPM 202 will not detect a hot coach, and stray voltages will cause damage to the CPM 202. [It] looks like we fried 2 CPMs (hot coach detectors) during troubleshooting.

The Electronic Technician looking at the location of the X60 connector that came loose or was disconnected.

10. Ensure the hot coach provide warning when there is a disconnected power supply at X60 in the Roof Top Compartment (RTC).
11. Ensure no coach ever enter into revenue service with the possibility of a "Hot Coach."
12. Ensure the lockout/tag out have the power source separated so that when a Mechanic is servicing a coach that bay is lockout/tag out and isolated from the other bays.

3. VK recognized that this is an issue and is working on a retro fit to the system so that if XT60, at CPM 11 has a power failure, or becomes disconnected the hot coach alarm and lights will activate.
